Volume 9 Issue 05, May 2025

SLOPE FAILURE ANALYSIS, CAUSES, AND SUSTAINABLE STABILIZATION MEASURES: CASE STUDY OF MUHANGA-KARONGI ROAD (PK 49), RUTSIRO DISTRICT, RWANDA

NIYIBIZI Jean Pierre* & BIZIMANA Hussein**

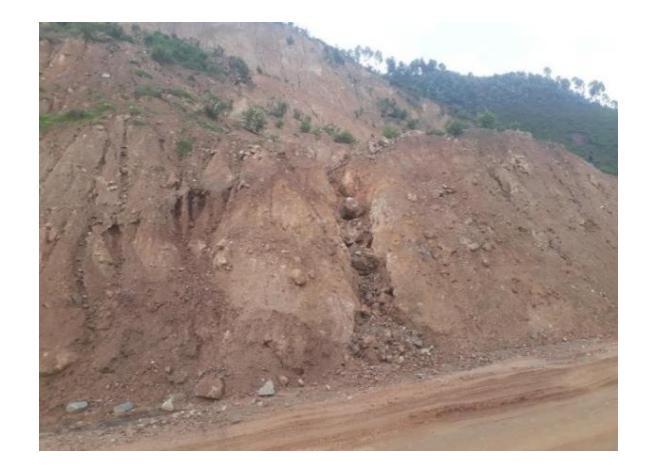
Figure 2: slope failure of the case study.

Figure 2 illustrates the physical manifestation of the slope failure captured during a field visit. The photograph shows evidence of toe collapse, surface erosion, and sediment displacement, all typical of rainfall-induced failures in saturated silty soils.

Such failures often begin with tension cracks near the crest and propagate downslope rapidly, especially when drainage is inadequate (Cho, 2024).

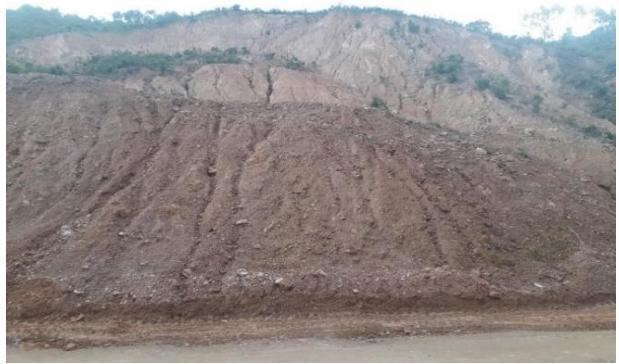
Figure 5: High Silt Soil at PK 49

The findings indicate a dominance of silty material with minimal clay content, which weakens cohesive bonding. While the moderately high friction angles provide some resistance to sliding, the low cohesion renders the slope vulnerable under external disturbances like rainfall infiltration or seismic activity. These results align with Rahardjo (2018), who demonstrated that cohesionless soils experience rapid shear strength loss during pore pressure increases, particularly under tropical rainfall conditions.

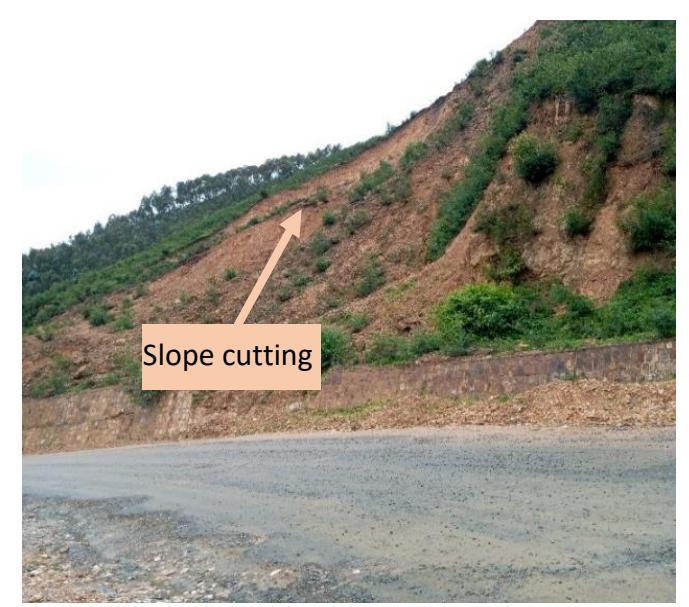
Figure 6: Evidence of Failure Induced by Slope Cutting at PK 49

As shown in Figure 6, exposed and steeply cut slopes were clearly visible during the field visit, lacking any structural reinforcement or protective facing. This type of undercutting increases the driving moment while reducing the resisting moment of the slope system. In effect, it lowers the factor of safety, making the slope highly vulnerable to even moderate hydrological loading, such as rainfall infiltration.

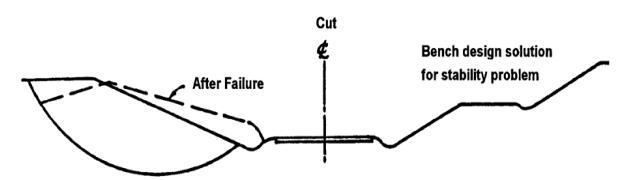
Figure 9: Deep-seated slope failure (left) and bench slope design (right) to ensure long-term stability- EZ Pdh, 2025

As shown in Figure 9, the existing slope failure at PK 49 is deep-seated and typifies conditions where slope angles exceed the mechanical capacity of the soil. On the right, the proposed bench design demonstrates how reducing slope steepness improves stability and accommodates hydrological control infrastructure such as interceptor drains or vegetated benches. This intervention is consistent with slope stabilization practices documented by Chen (2021), who observed that benching significantly improved the factor of safety in tropical, rain-fed hilly terrains similar to Rwanda's Western Province.

A recommended stabilization measure is the implementation of slope benching at a ratio of 2. 2H:1V, which corresponds to an approximate slope angle of 23°. This regrading substantially reduces the downslope driving force and increases the resisting force by aligning slope geometry with the soil's shear strength. Bench slopes also allow surface runoff to be better managed by disrupting water concentration along long, steep profiles.
