Volume 9 Issue 05, May 2025

SLOPE FAILURE ANALYSIS, CAUSES, AND SUSTAINABLE STABILIZATION MEASURES: CASE STUDY OF MUHANGA-KARONGI ROAD (PK 49), RUTSIRO DISTRICT, RWANDA

NIYIBIZI Jean Pierre* & BIZIMANA Hussein**

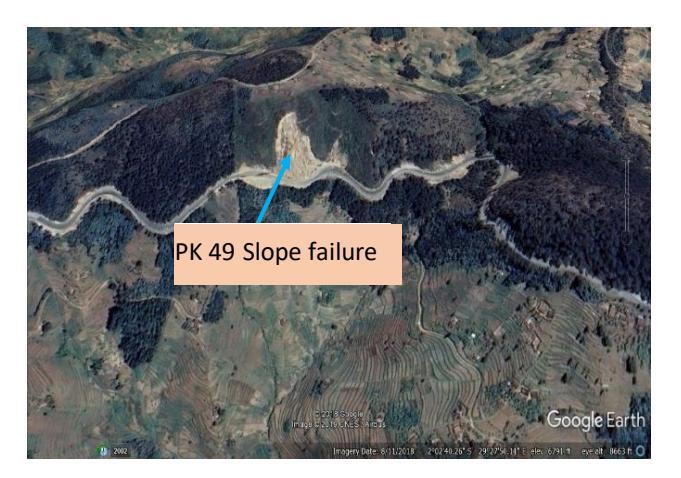
Figure 2 illustrates the physical manifestation of the slope failure captured during a field visit. The photograph shows evidence of toe collapse, surface erosion, and sediment displacement, all typical of rainfall-induced failures in saturated silty soils.

Such failures often begin with tension cracks near the crest and propagate downslope rapidly, especially when drainage is inadequate (Cho, 2024).

Figure 2: slope failure of the case study.

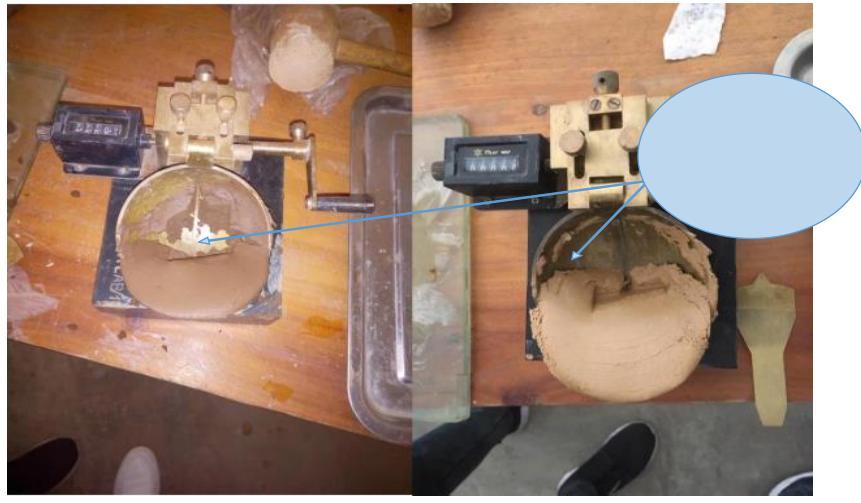
Figure 4: Liquid Limit Test Result.

At the PK 49 slope site, attempts to determine the plasticity index using the Casagrande apparatus were unsuccessful. As shown in Figure 4, the soil failed to form a cohesive groove and instead flowed out uncontrollably, demonstrating non-plastic behavior.

This result is typical of soils composed predominantly of silt with low clay content. According to Chen (2021), silty soils with insufficient clay minerals lack the electrochemical bonding that provides plasticity and cohesion under variable moisture conditions. As a result, such soils have reduced resistance to deformation and exhibit poor load-bearing capacity, particularly during saturation.
